Coastal Erosion Protection

Project Reference : Cebu City Coastal Road, Philippines
Application : Coastal Erosion Protection
Grade : Rock WX100/100 Geotextile

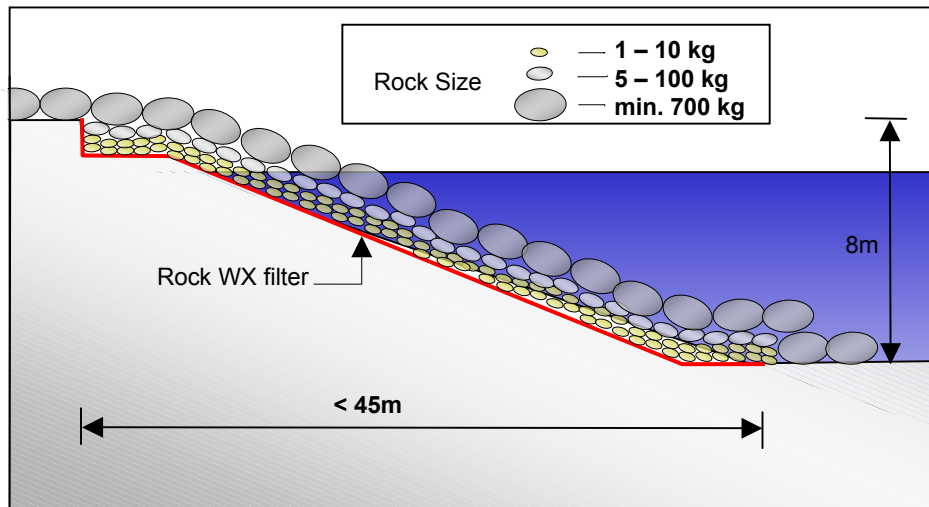
Figure 1. Typical cross sectioned of armour rock protection system with woven knitted geotextile filter.

The armour protection system consisted of a knitted high strength polyester geotextile filter together with secondary and primary armour rocks.

Revetment consisted of two secondary layers of stone with a weight 1- 10kg and 5 –100 kg respectively. The secondary armour rock layers ensured that the geotextile filter is in intimate contact with the underlying soil to ensure internal soil erosion does not occur. The rock used for the primary armour layer consists of a minimum weight > 700 kg. Underwater camera was used during the installation of the primary rock layer to ensure that the final armour rocks protection system profile meet the design requirements.

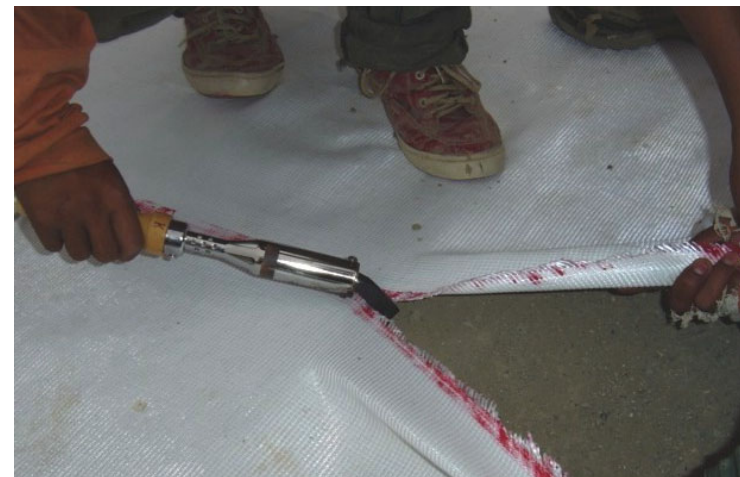
Figure 2. Cutting of geotextile using a heated hot blade.

The knitted geotextile filter was precut with the aid of a hot blade to the required length (< 45m) based on the water depth and topographical survey. Each panel was labeled so that the length was sufficient for the respective depth. The geotextile filter are then coiled into a steel bar and unrolled along the slope into the sea bed with the aid of 4 underwater divers.

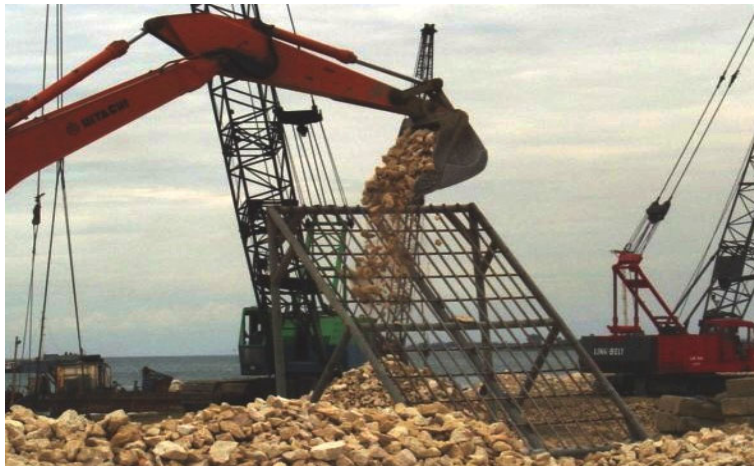
Figure 3. Stringent control using sieving to ensure secondary armour rock gradation meets the requirements.

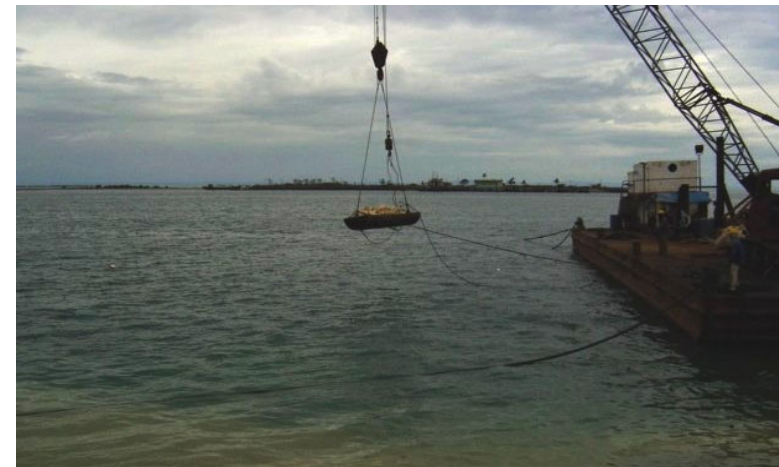
Figure 4. Dumping of secondary armour rock onto seabed.

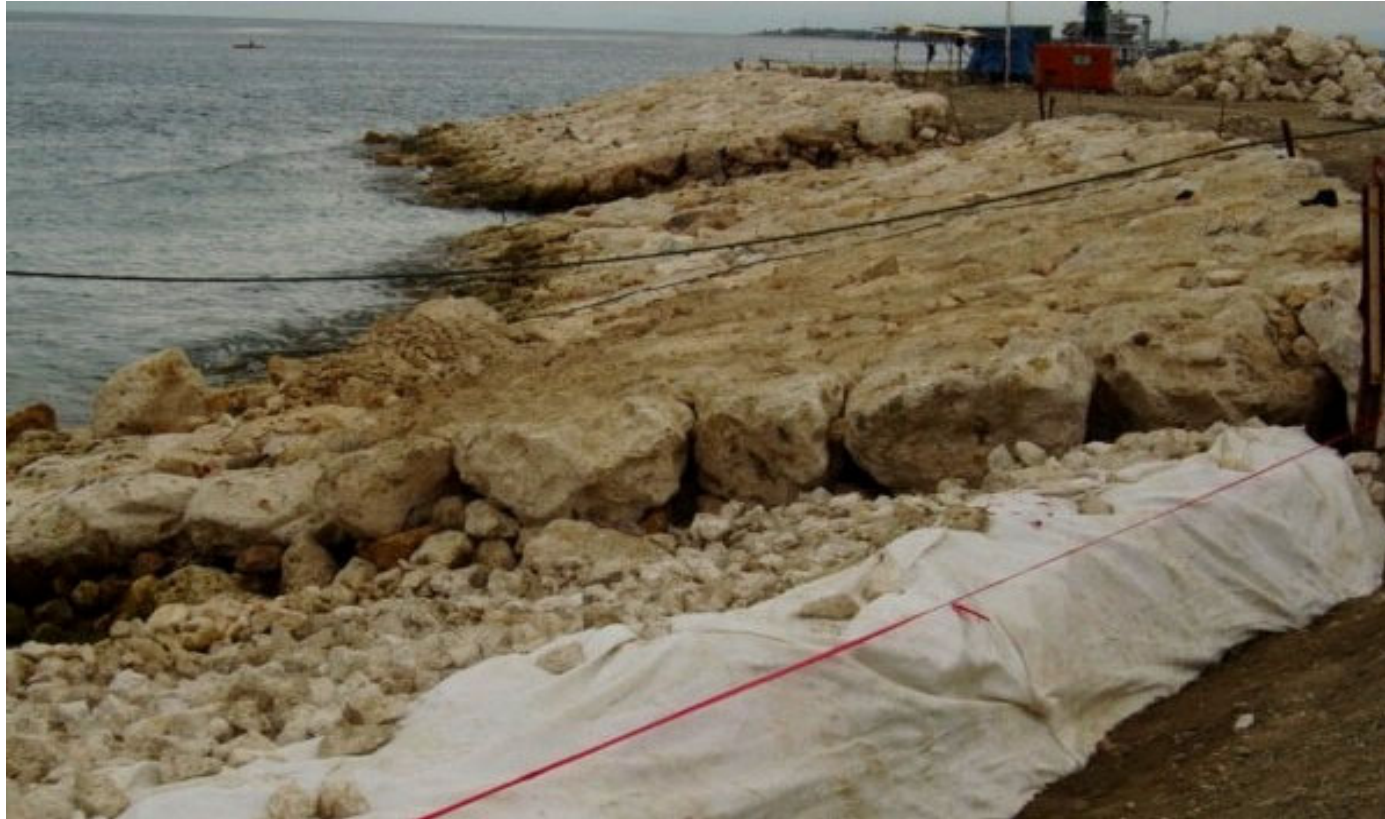
Figure 5. Overview of high strength woven geotextile filter with armour rock protection system.
