## MUGGA LANE LANDFILL SYMONSTON, ACT, AUSTRALIA

### ENVIRONMENTAL/HYDRAULIC ENGINEERING/MATRESS CHANNEL LINING

#### Product: Maccaferri Galmac+PVC Coated Gabion and Reno Mattresses

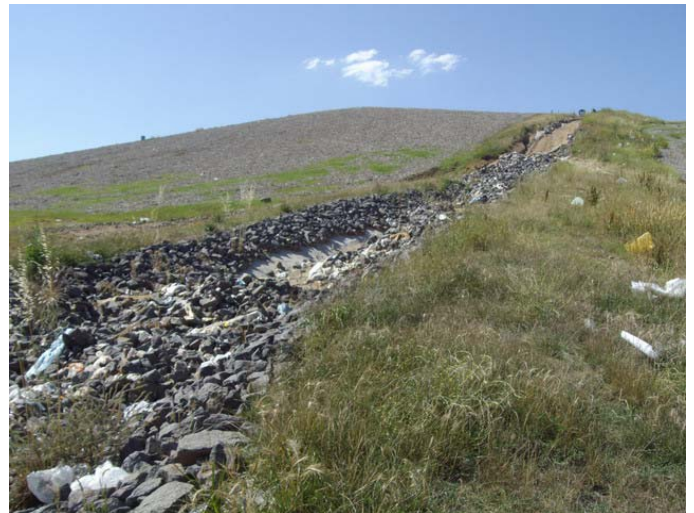
The Storm Damage To The Loose Rock

Date: Jan 2008

Maunsell approached Maccaferri to conduct the preliminary hydraulic analysis of the batter drain utilising Gabions and Reno Mattresses. The design suggestion was carried out using the Maccaferri MACRA 1 software. Gabion Mattresses (6x2x0.5) were specified at the base of the channel section where the velocities and shear stresses (tractive forces) were expected to be the highest. Castoro Reno Mattresses (6x2x0.30) with a double internal diaphragm at 1m centres were specified on the sides of the channel. Geomac 330 non-woven geotextile was used as the separation layer beneath the Mattress protection.

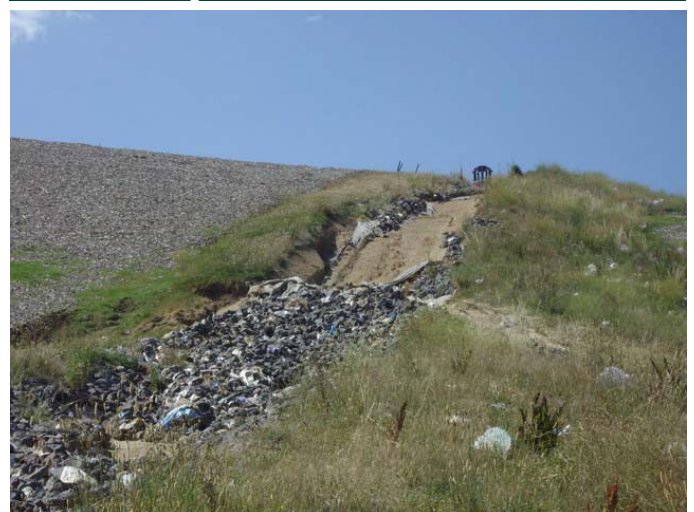
Loose Rock Washed Down The Channel

Date: Jan 2008

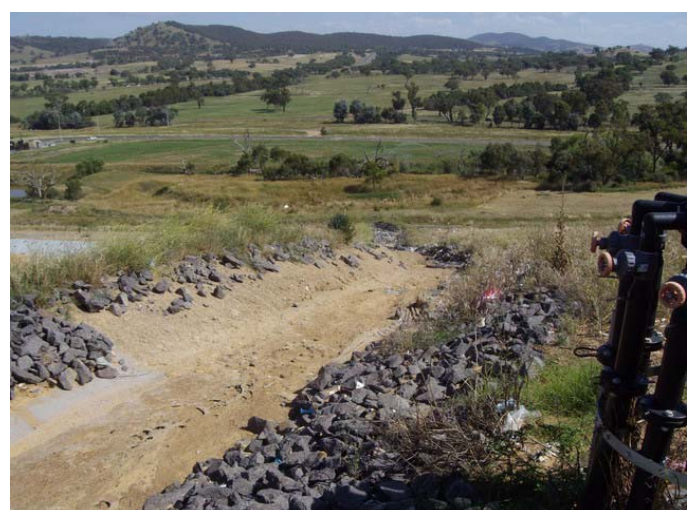
Close Up Of The Damaged Loose Rock

Date: Jan 2008
